NBSIR 74-390

ELECTROMAGNETIC NOISE IN ITMANN MINE

Electromagnetics Division
Institute for Basic Standards
National Bureau of Standards
Boulder, Colorado 80302

June 1974

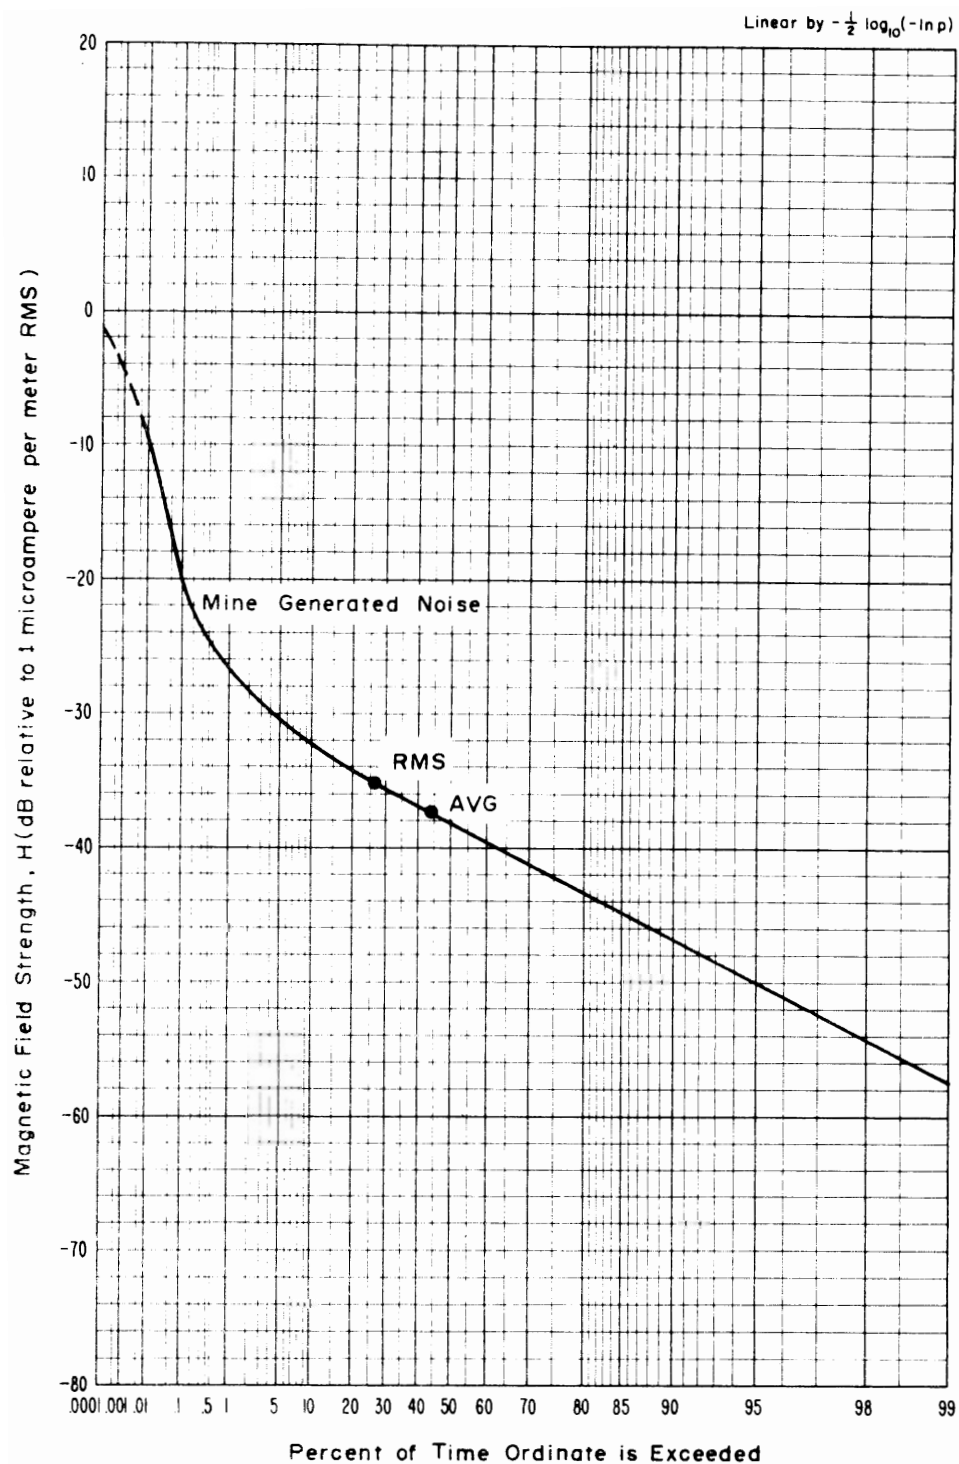
Figure 4-24 APD, 130 kHz, vertical component, 1.0 kHz predetection bandwidth, April 17, 1973, 2:45 p.m., Farley Panel, Itmann #3.

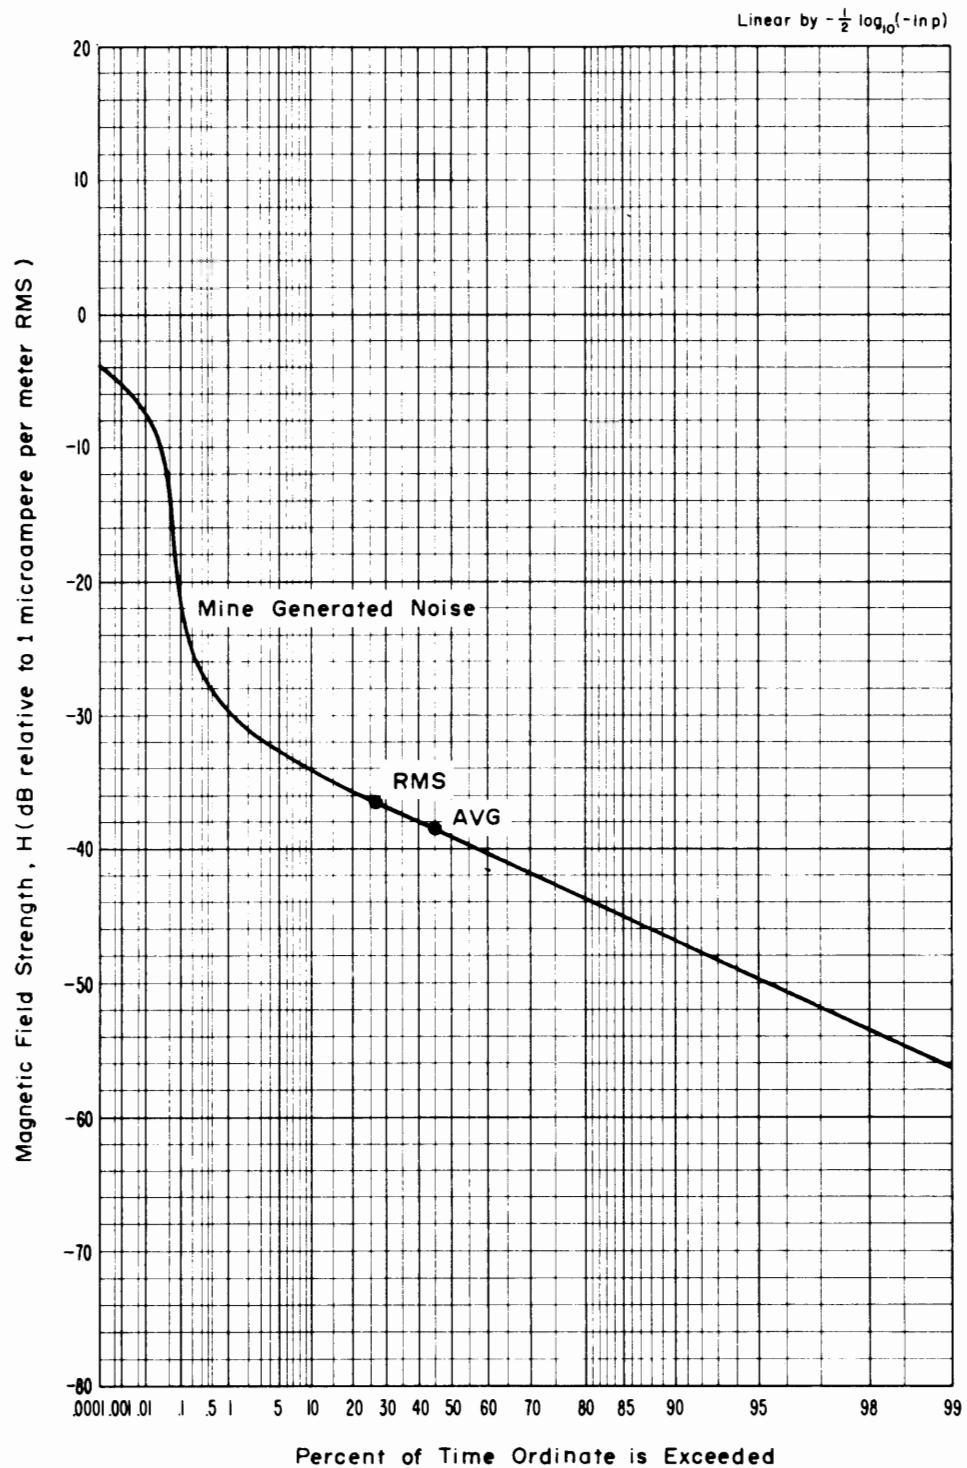
Figure 4-25 APD, 250 kHz, vertical component, 1.2 kHz predetection bandwidth, April 17, 1973, 12:30 p.m., Farley Panel, Itmann #3.

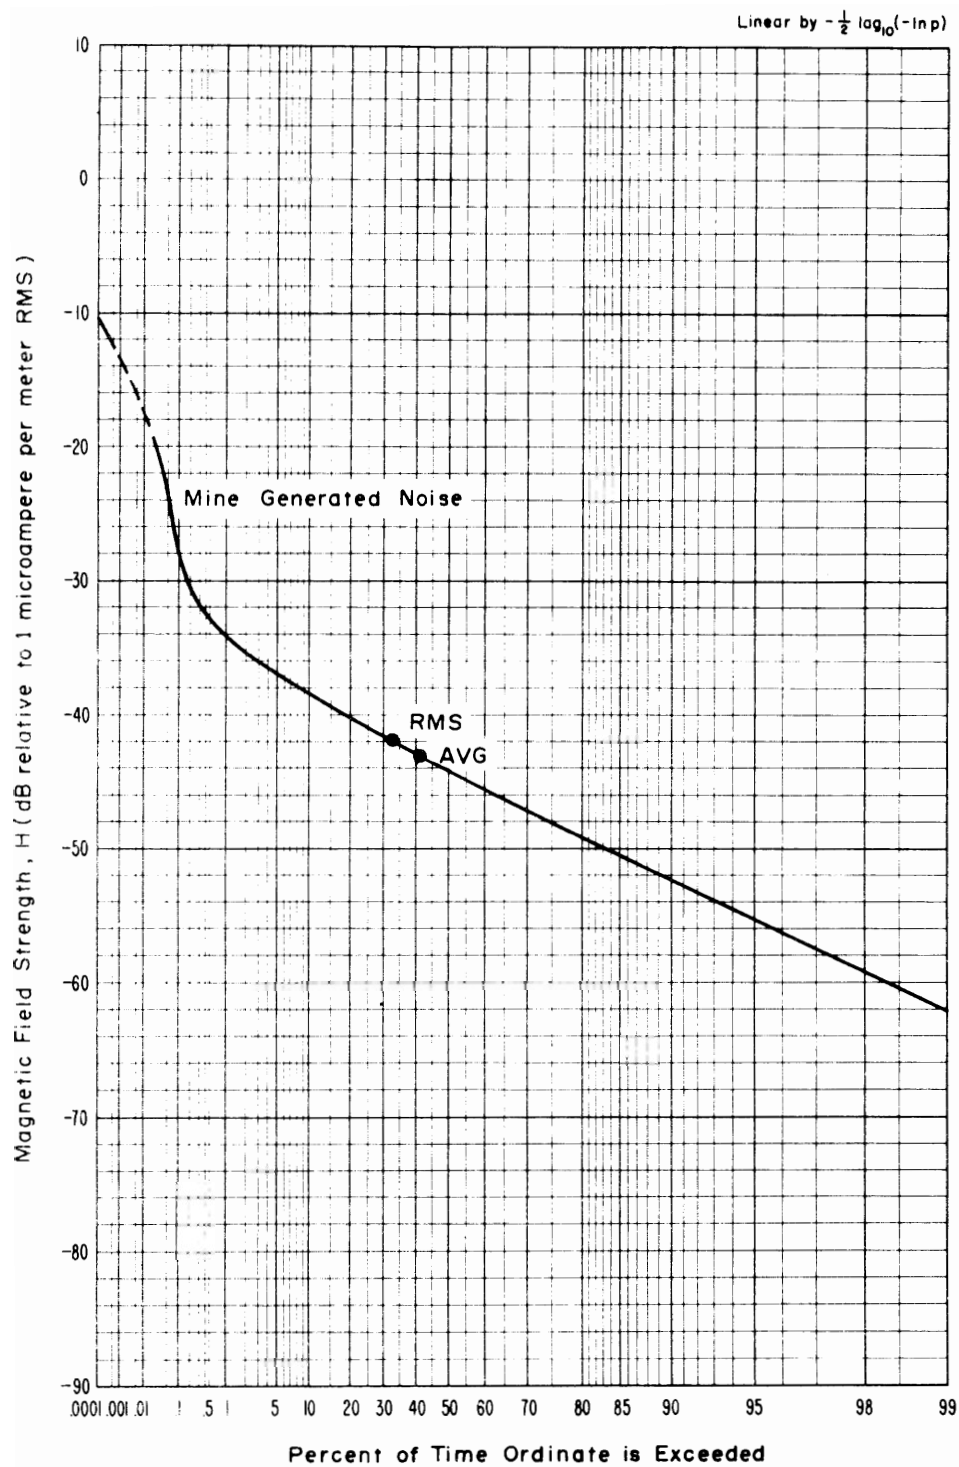
Figure 4-26 APD, 500 kHz, vertical component, 1.2 kHz predetection bandwidth, April 17, 1973, 1:15 p.m., Farley Panel, Itmann #3.

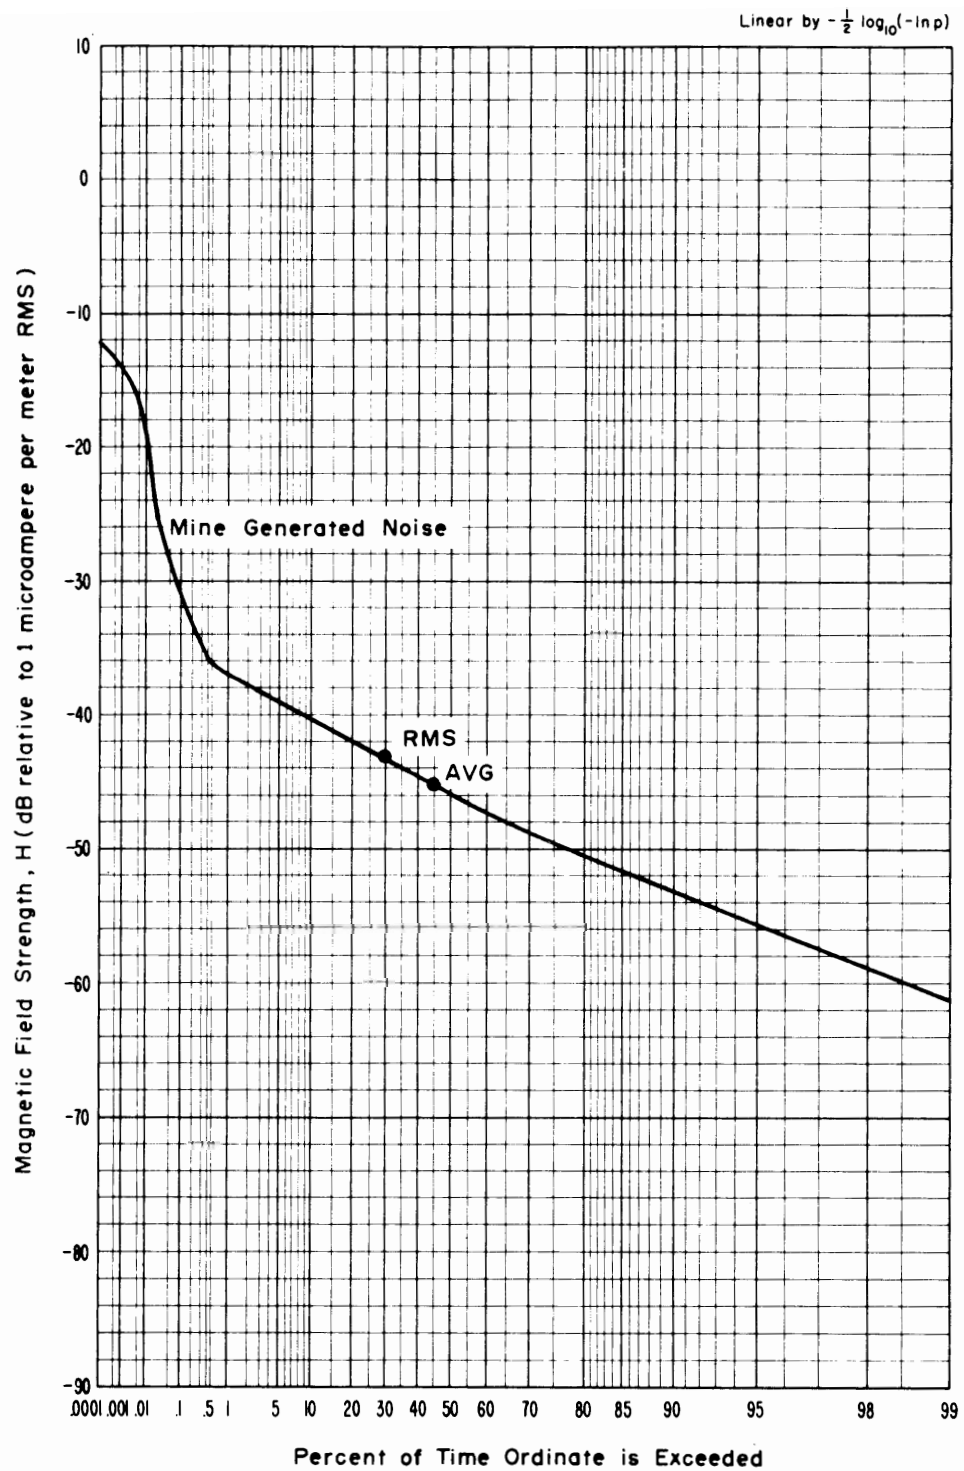
Figure 4-27 APD, 1 MHz, vertical component, 1.2 kHz predetection bandwidth, April 17, 1973, 2:00 p.m., Farley Panel, Itmann #3.

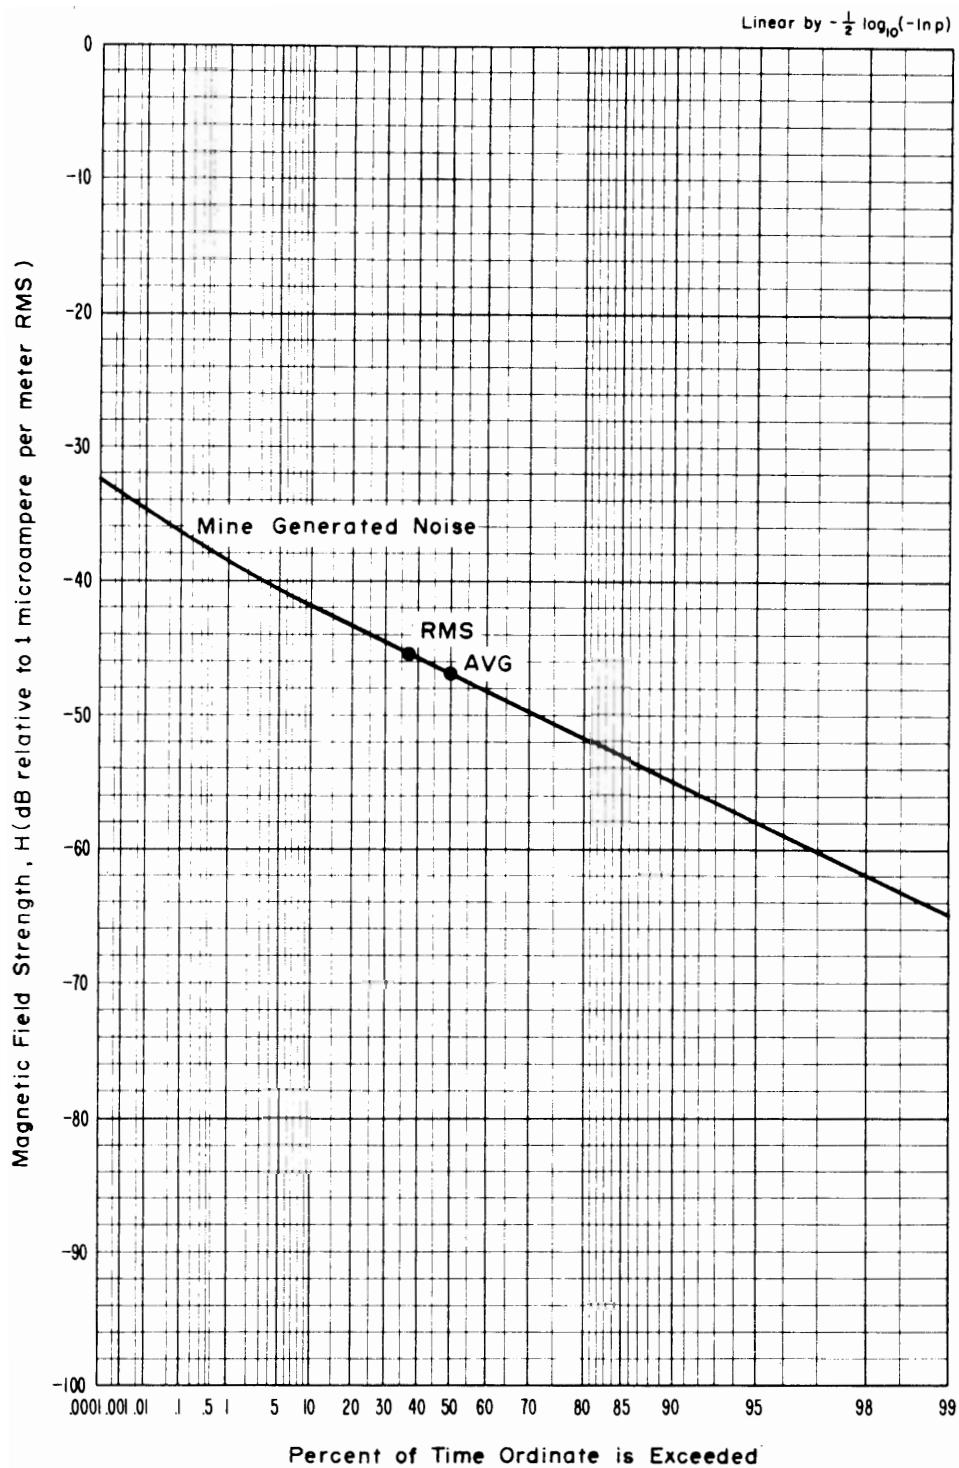
Figure 4-28 APD, 2 MHz, vertical component, 1.2 kHz predetection bandwidth, April 17, 1973, 2:45 p.m., Farley Panel, Itmann #3.

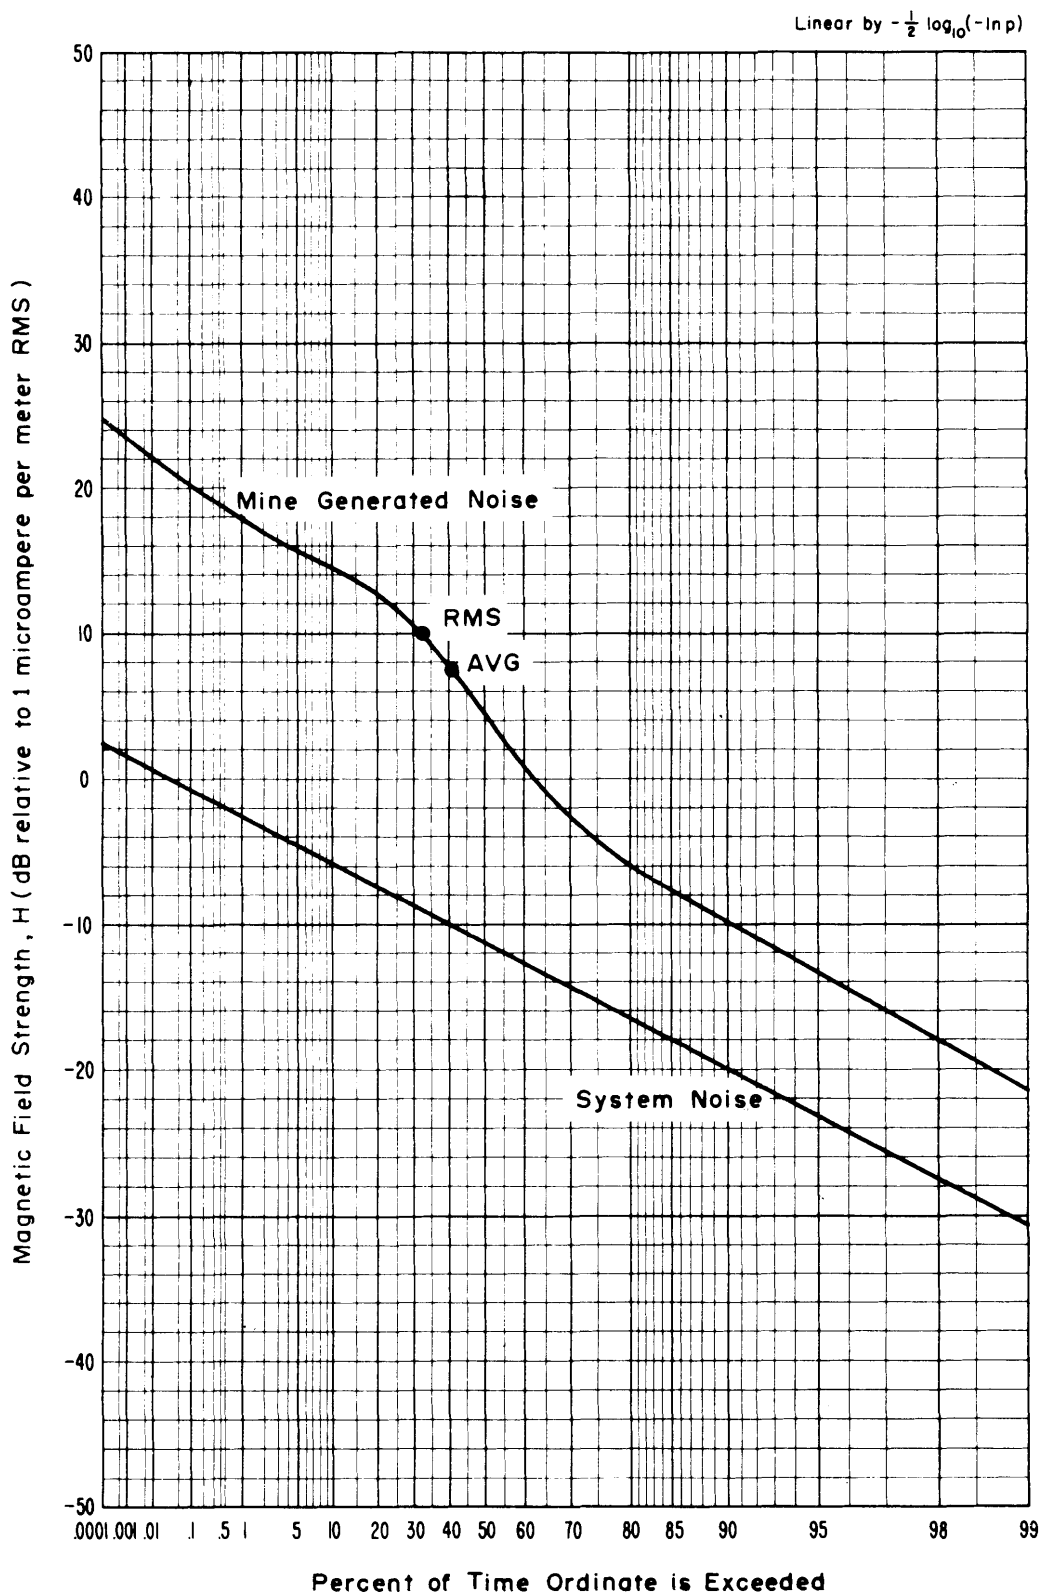
Figure 4-29 APD, 10 kHz, vertical component, 1.0 kHz predetection bandwidth,
April 19, 1973, 10:20 a.m., Farley Headpiece, Itmann #3.

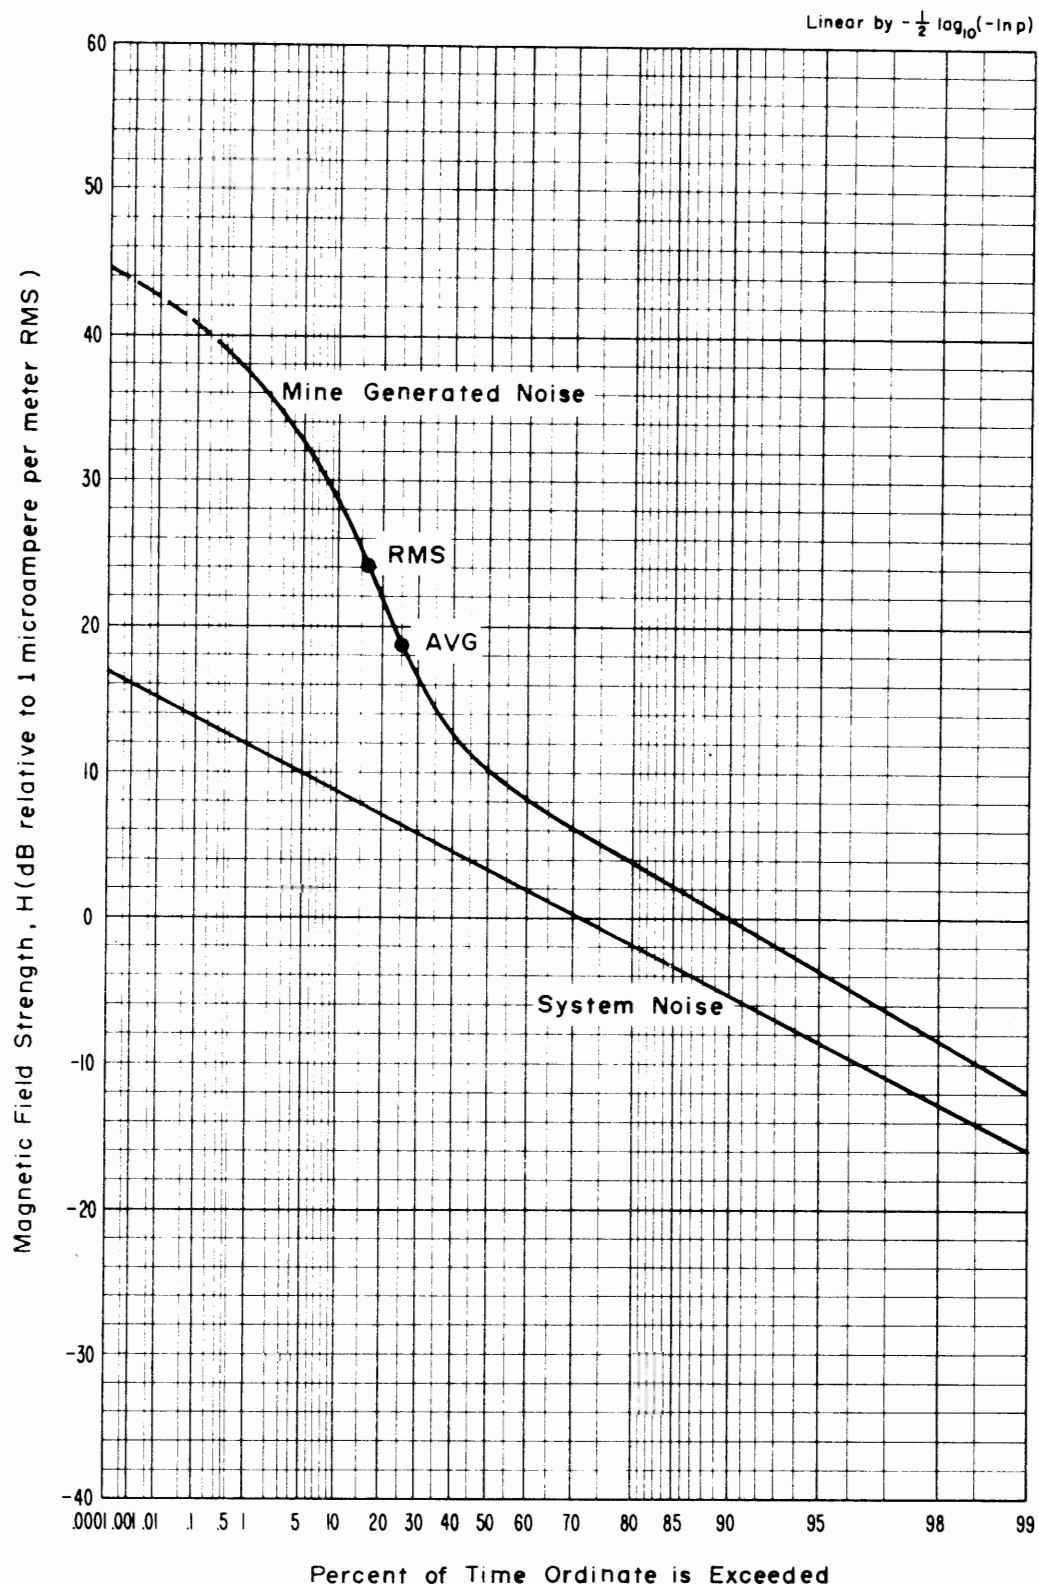
Figure 4-30 APD, 30 kHz, vertical component, 1.0 kHz predetection bandwidth, April 19, 1973, 10:50 a.m., Farley Headpiece, Itmann #3.

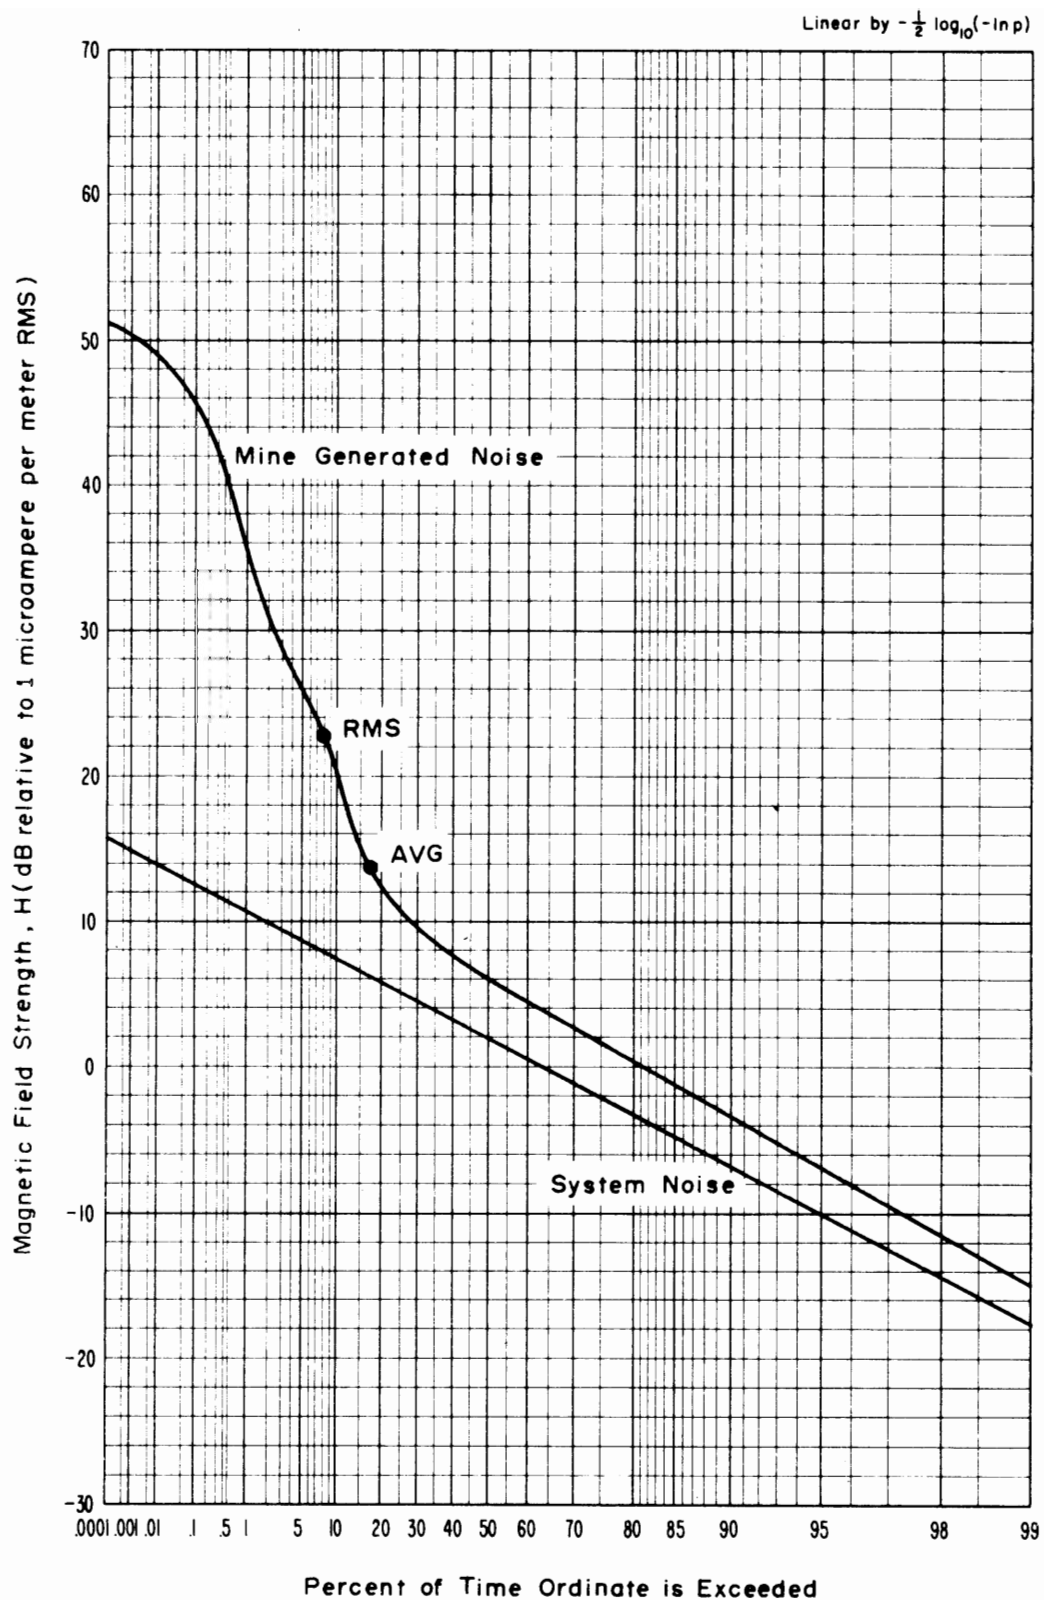
Figure 4-31 APD, 70 kHz, vertical component, 1.0 kHz predetection bandwidth, April 19, 1973, 11:25 a.m., Farley Headpiece, Itmann #3.

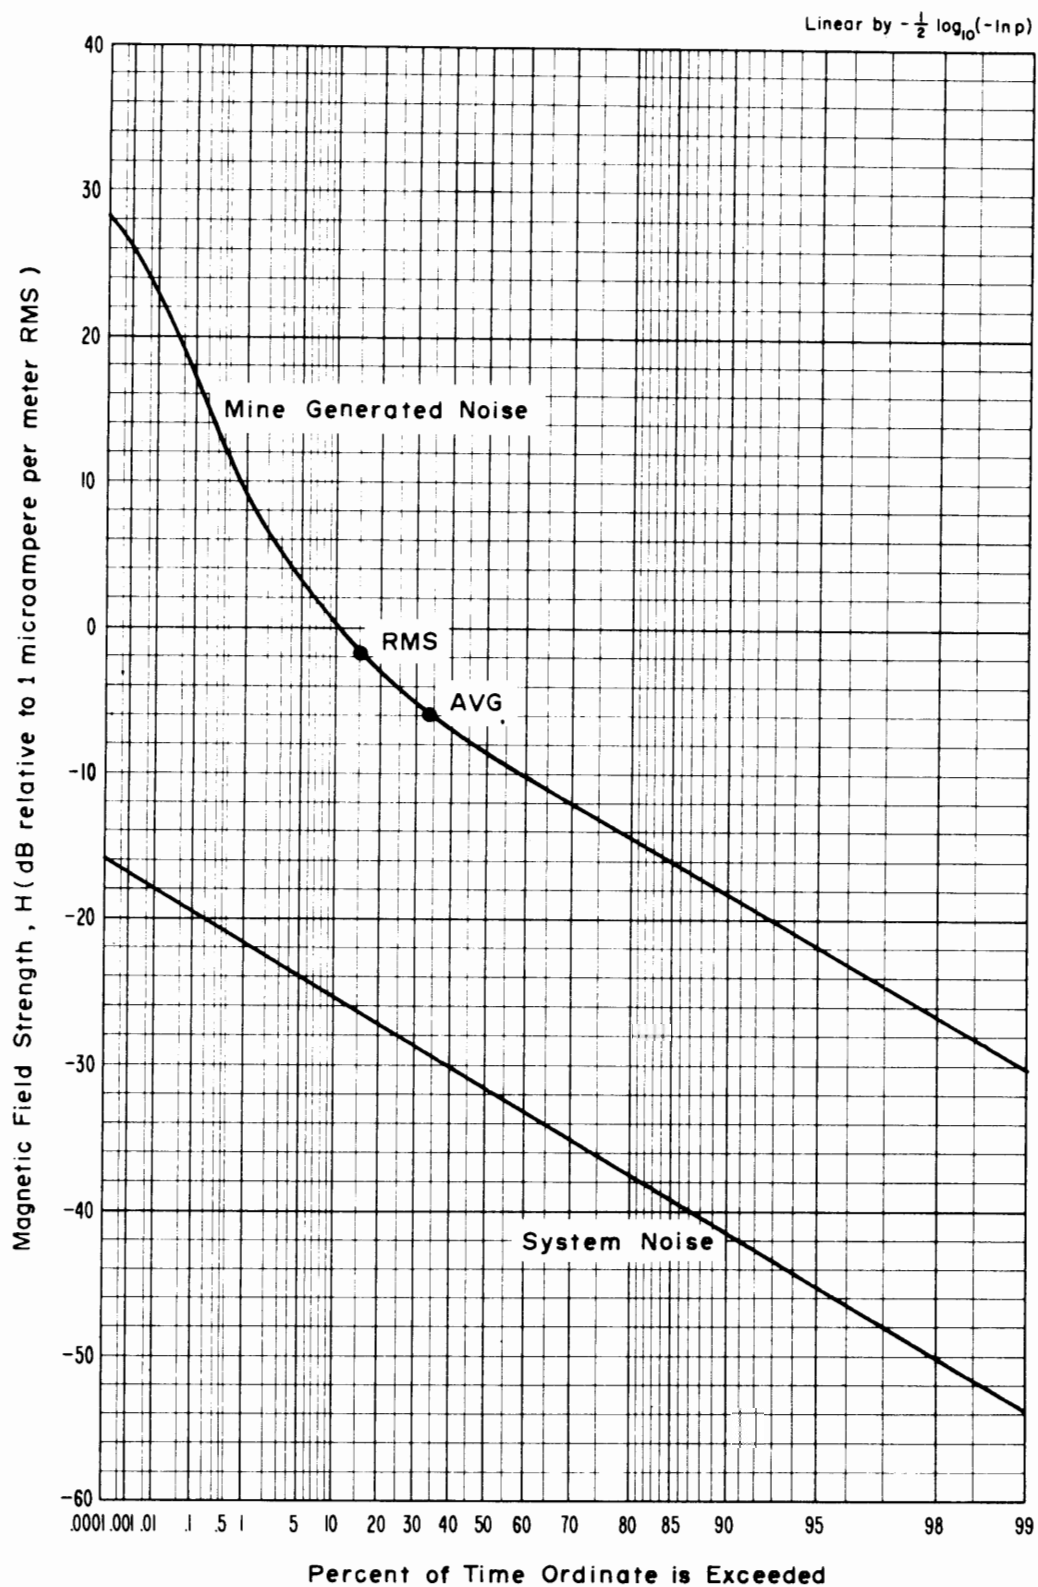
Figure 4-32 APD, 130 kHz, vertical component, 1.0 kHz predetection bandwidth,
April 19, 1973, 12:00 p.m., Farley Headpiece, Itmann #3.

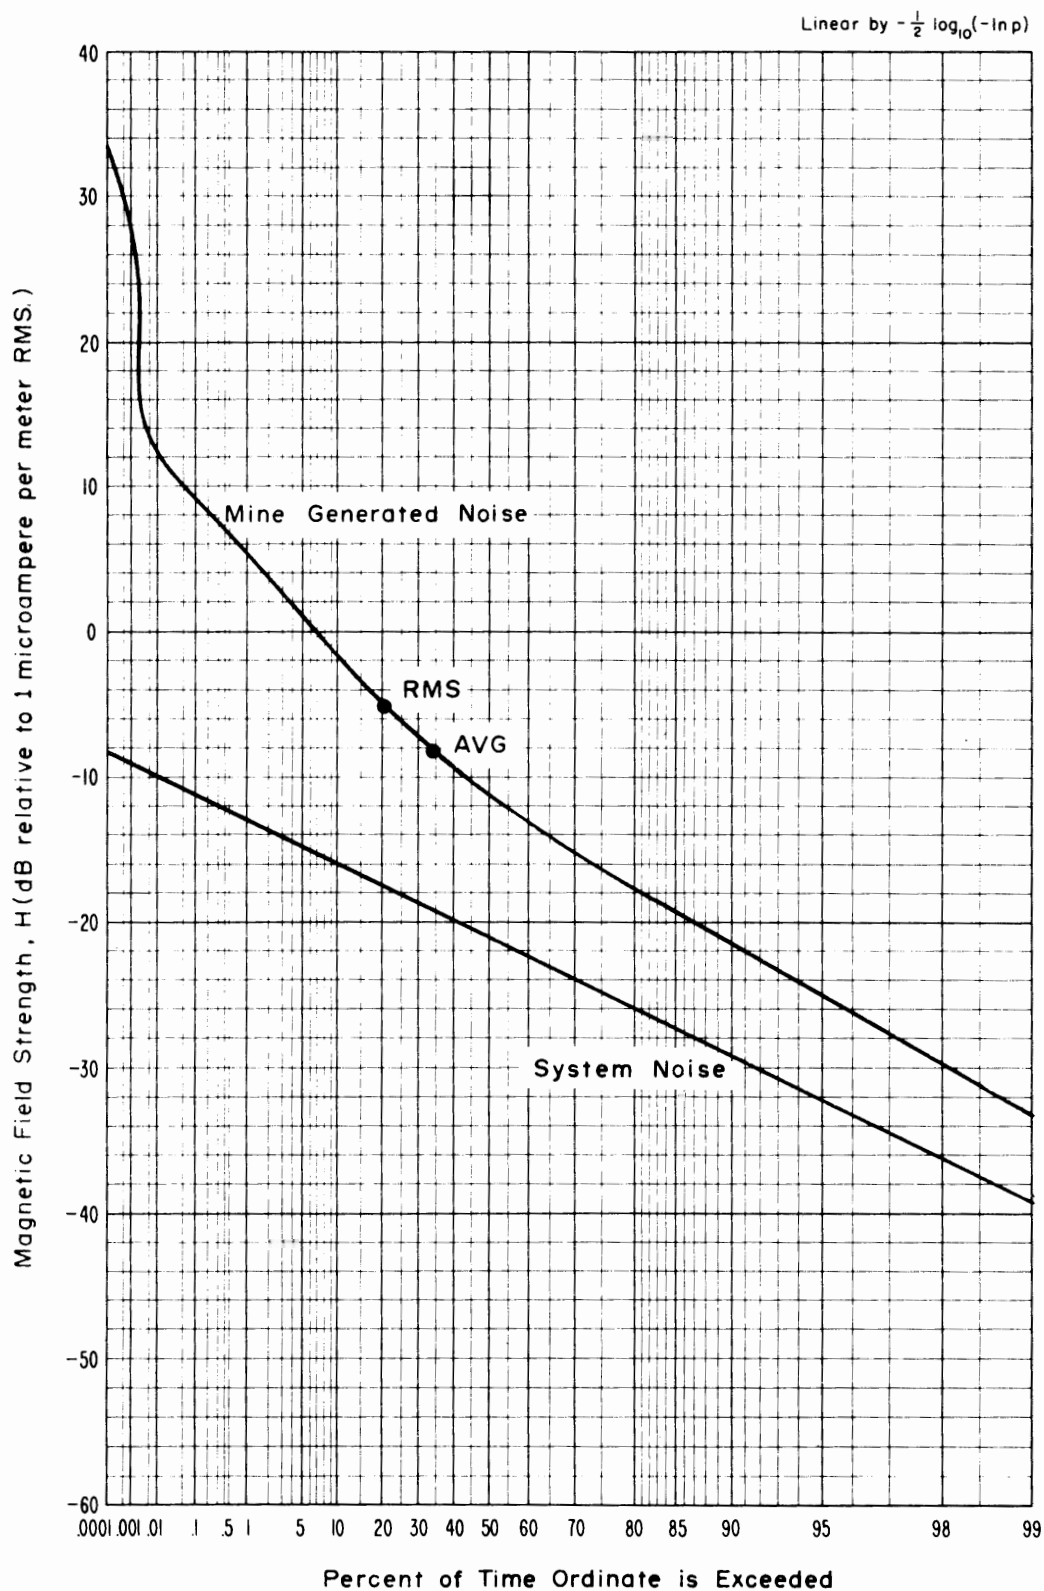
Figure 4-33 APD, 160 kHz, vertical component, 1.0 kHz predetection bandwidth, April 19, 1973, 12:30 p.m., Farley Headpiece, Itmann #3.

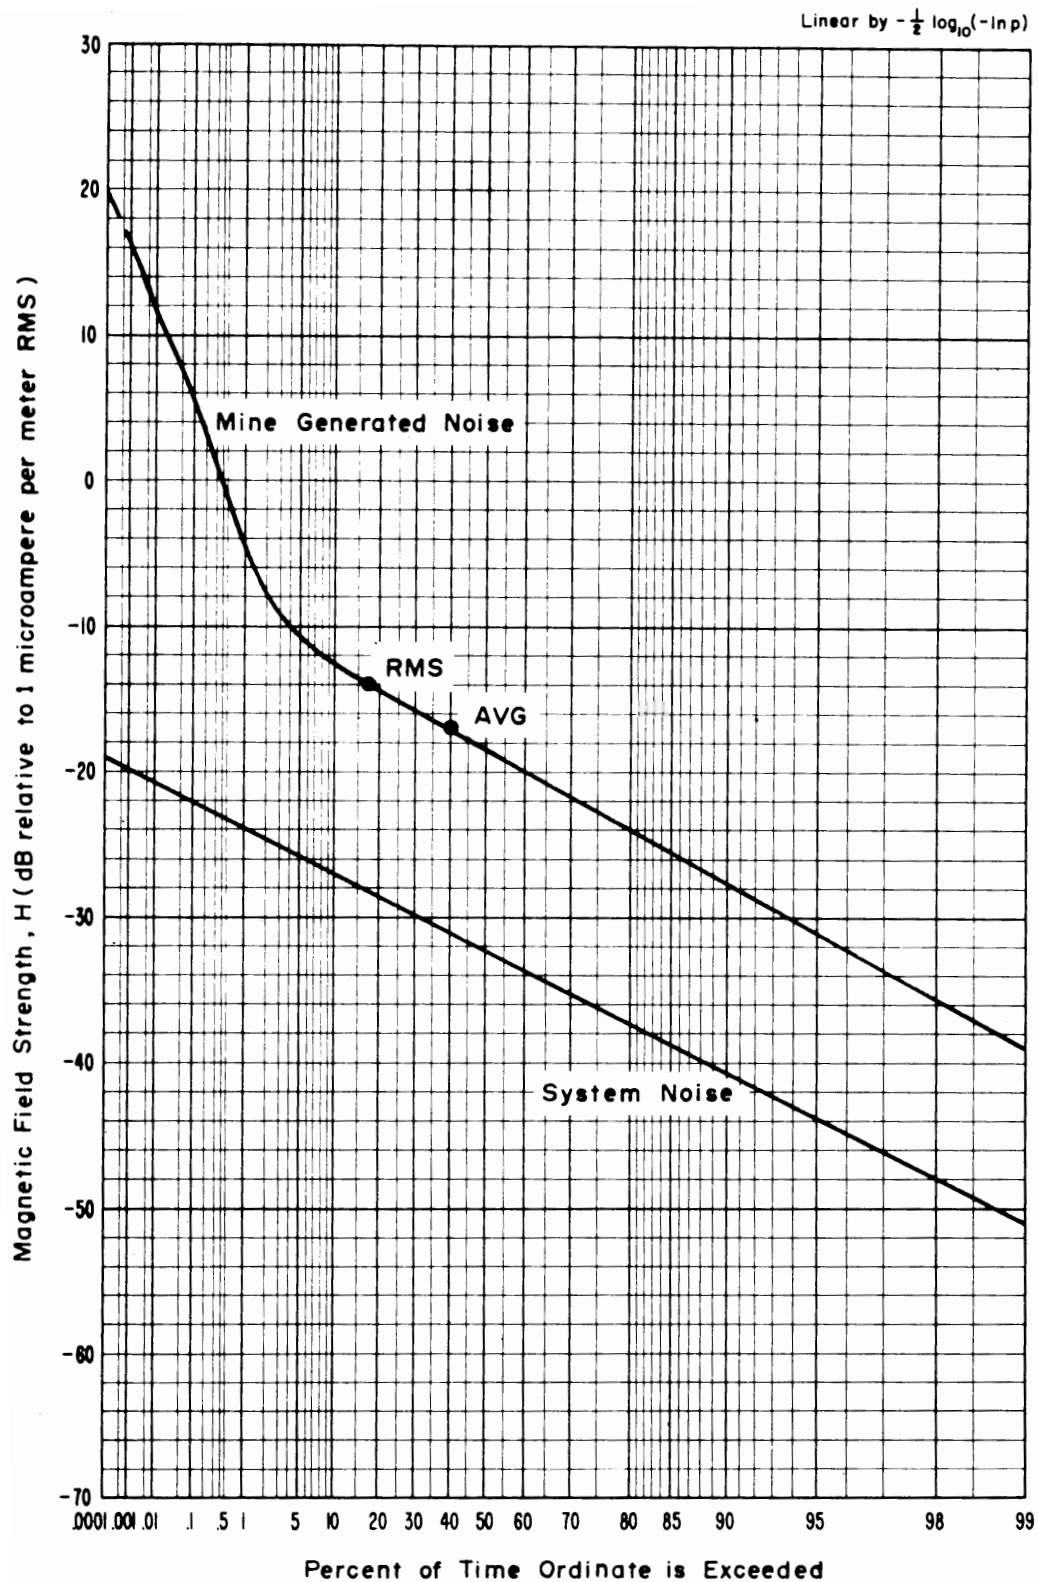
Figure 4-34 APD, 250 kHz, vertical component, 1.0 kHz predetection bandwidth,
April 19, 1973, 1:00 p.m., Farley Headpiece, Itmann #3.

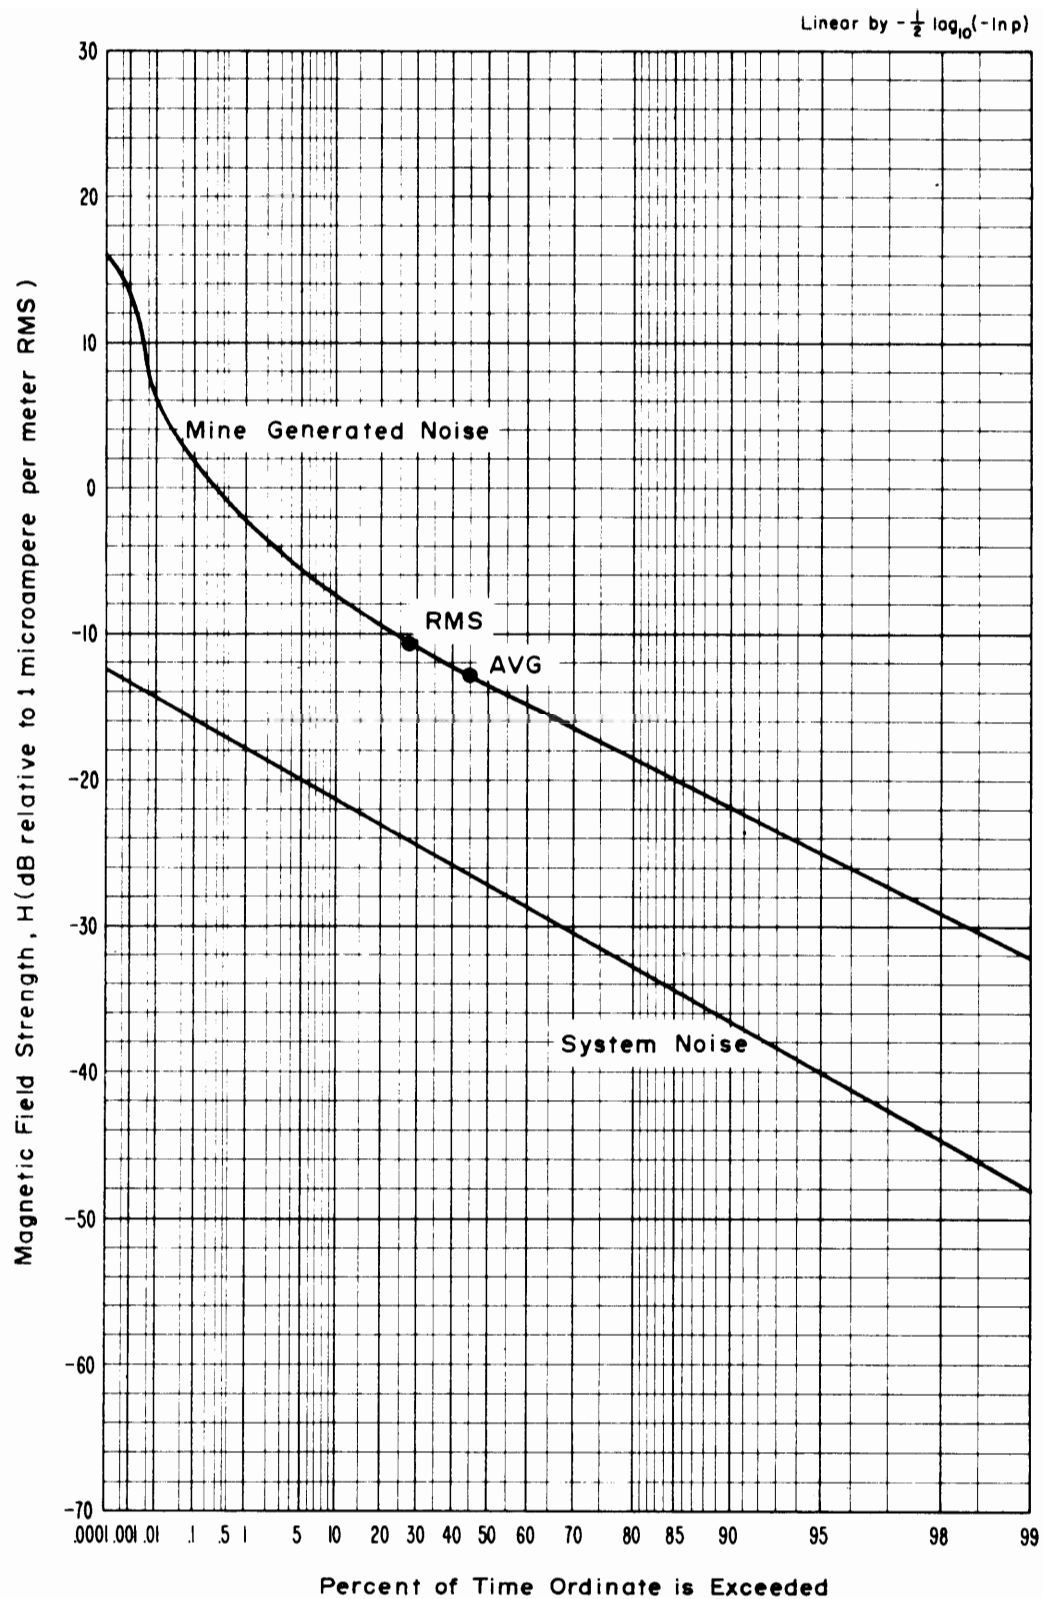
Figure 4-35 APD, 500 kHz, vertical component, 1.2 kHz predetection bandwidth, April 19, 1973, 10:20 a.m., Farley Headpiece, Itmann #3.

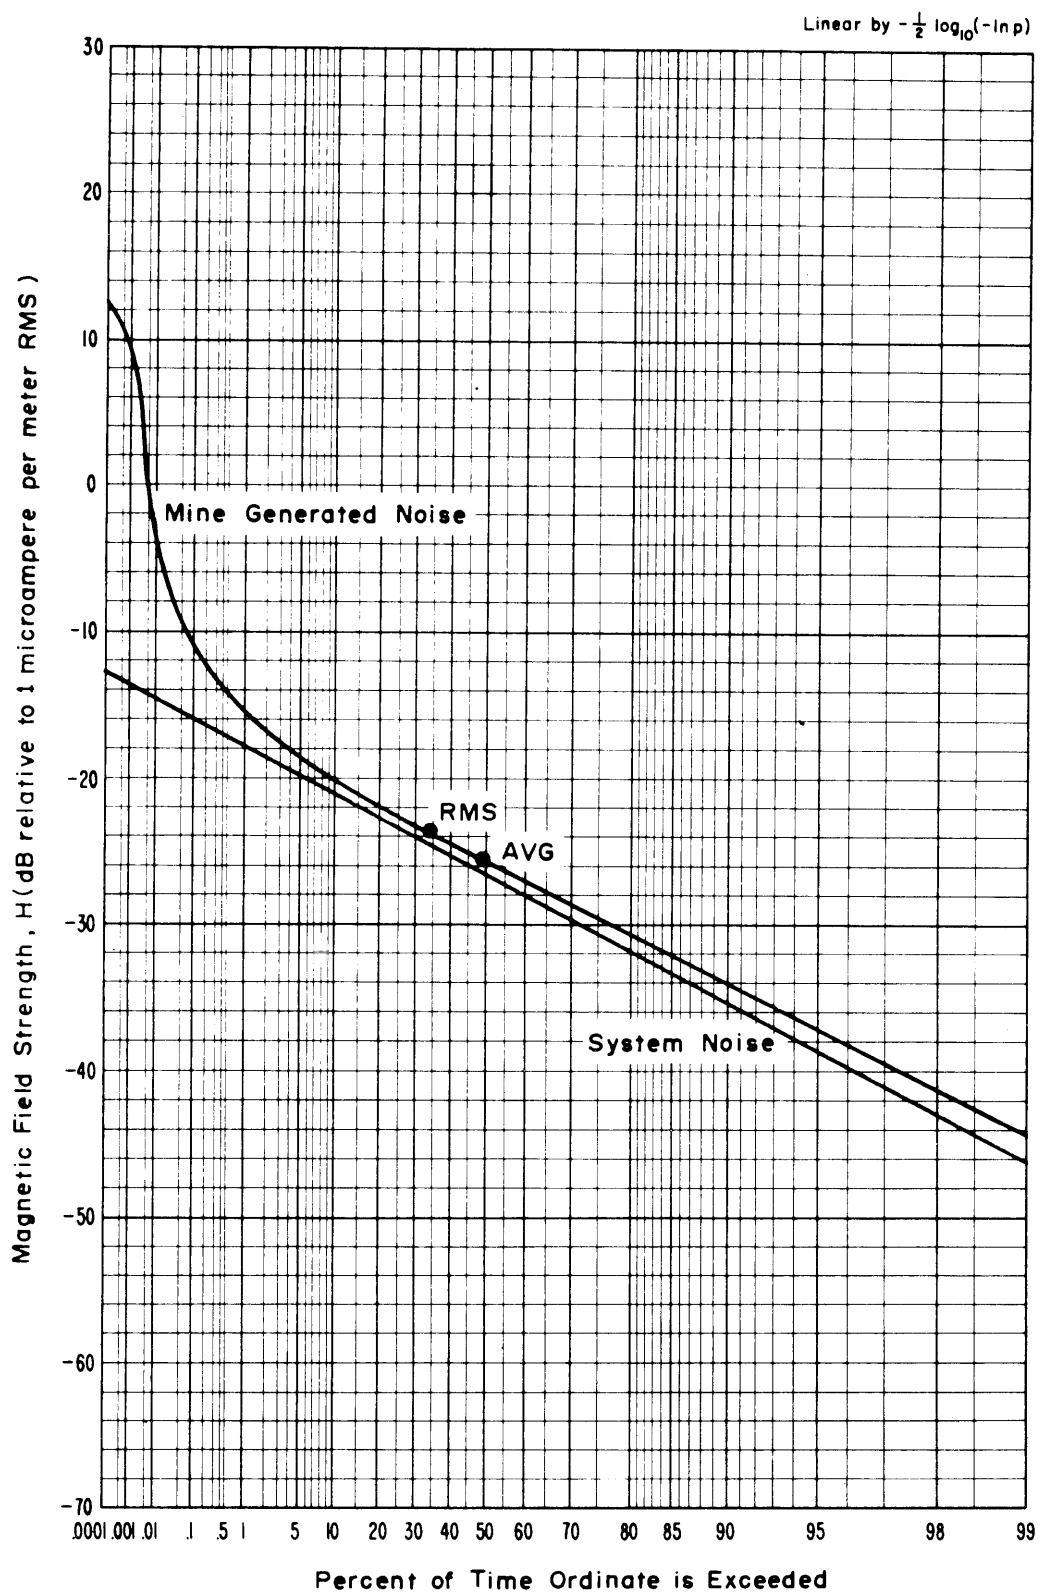
Figure 4-36 APD, 1 MHz, vertical component, 1.2 kHz predetection bandwidth, April 19, 1973, 10:50 a.m., Farley Headpiece, Itmann #3.

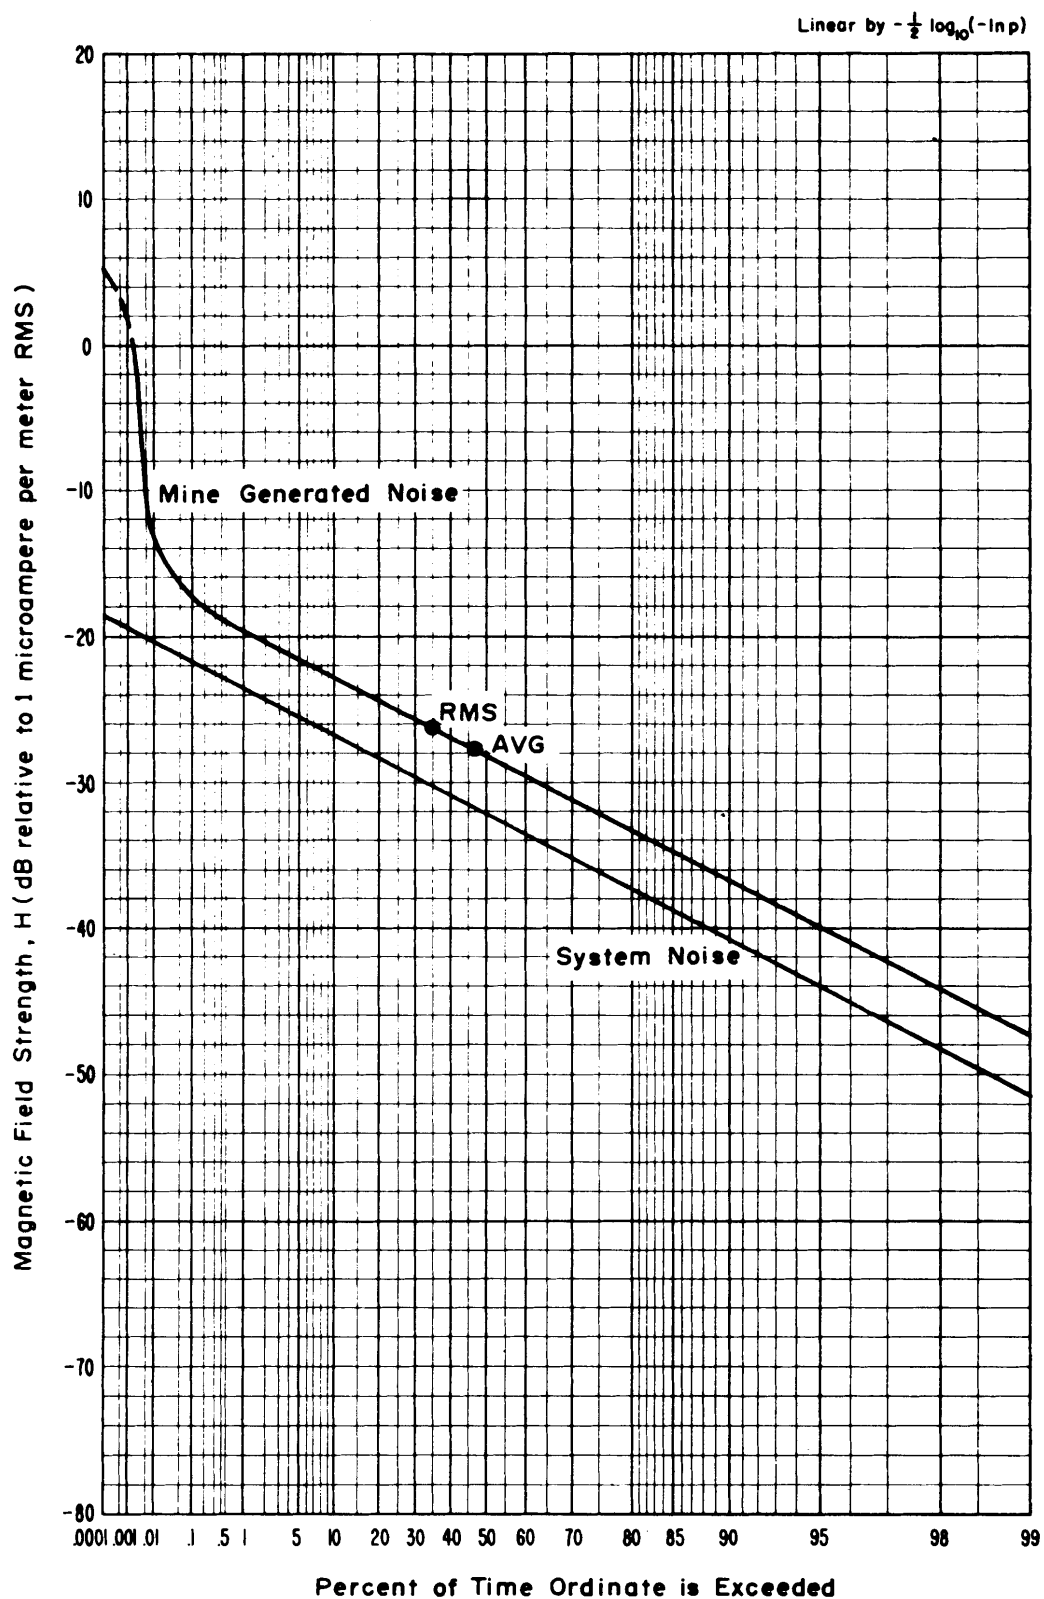
Figure 4-37 APD, 2 MHz, vertical component, 1.2 kHz predetection bandwidth, April 19, 1973, 11:25 a.m., Farley Headpiece, Itmann #3.
